# Manhole Inspection Summary

Manhole # S13II\_040MH

**Location** Address: **1814 N DUKELAND ST** Cross Street: **W NORTH AVE**

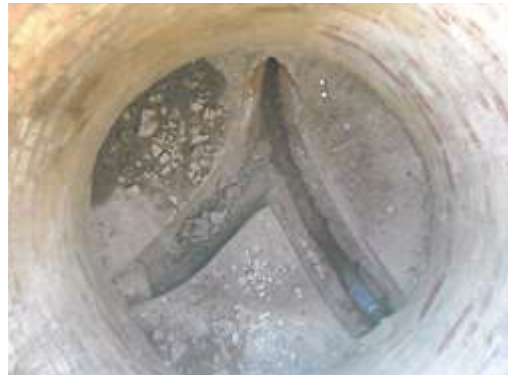
Top View

Comments **FOUND CRACKED 30" LID ON 2-21-09. ON 2-23 BROKE AND REPLACED PREVIOUS LID. USED 16LB SLEDGE AND PICKAXE TO PRY OPEN. INSPECTION COMPLETE.**
